ABSTRACT
A major landslide occurred on the south side of Cotton Brook in the Mt. Mansfield State Forest in May 2019. The immediate goals of the Vermont Geological Survey were to 1) document threats in the area, 2) characterize the site, 3) propose approximate "exclusion areas" for trails, and 4) collect baseline data so we can evaluate impacts and change.

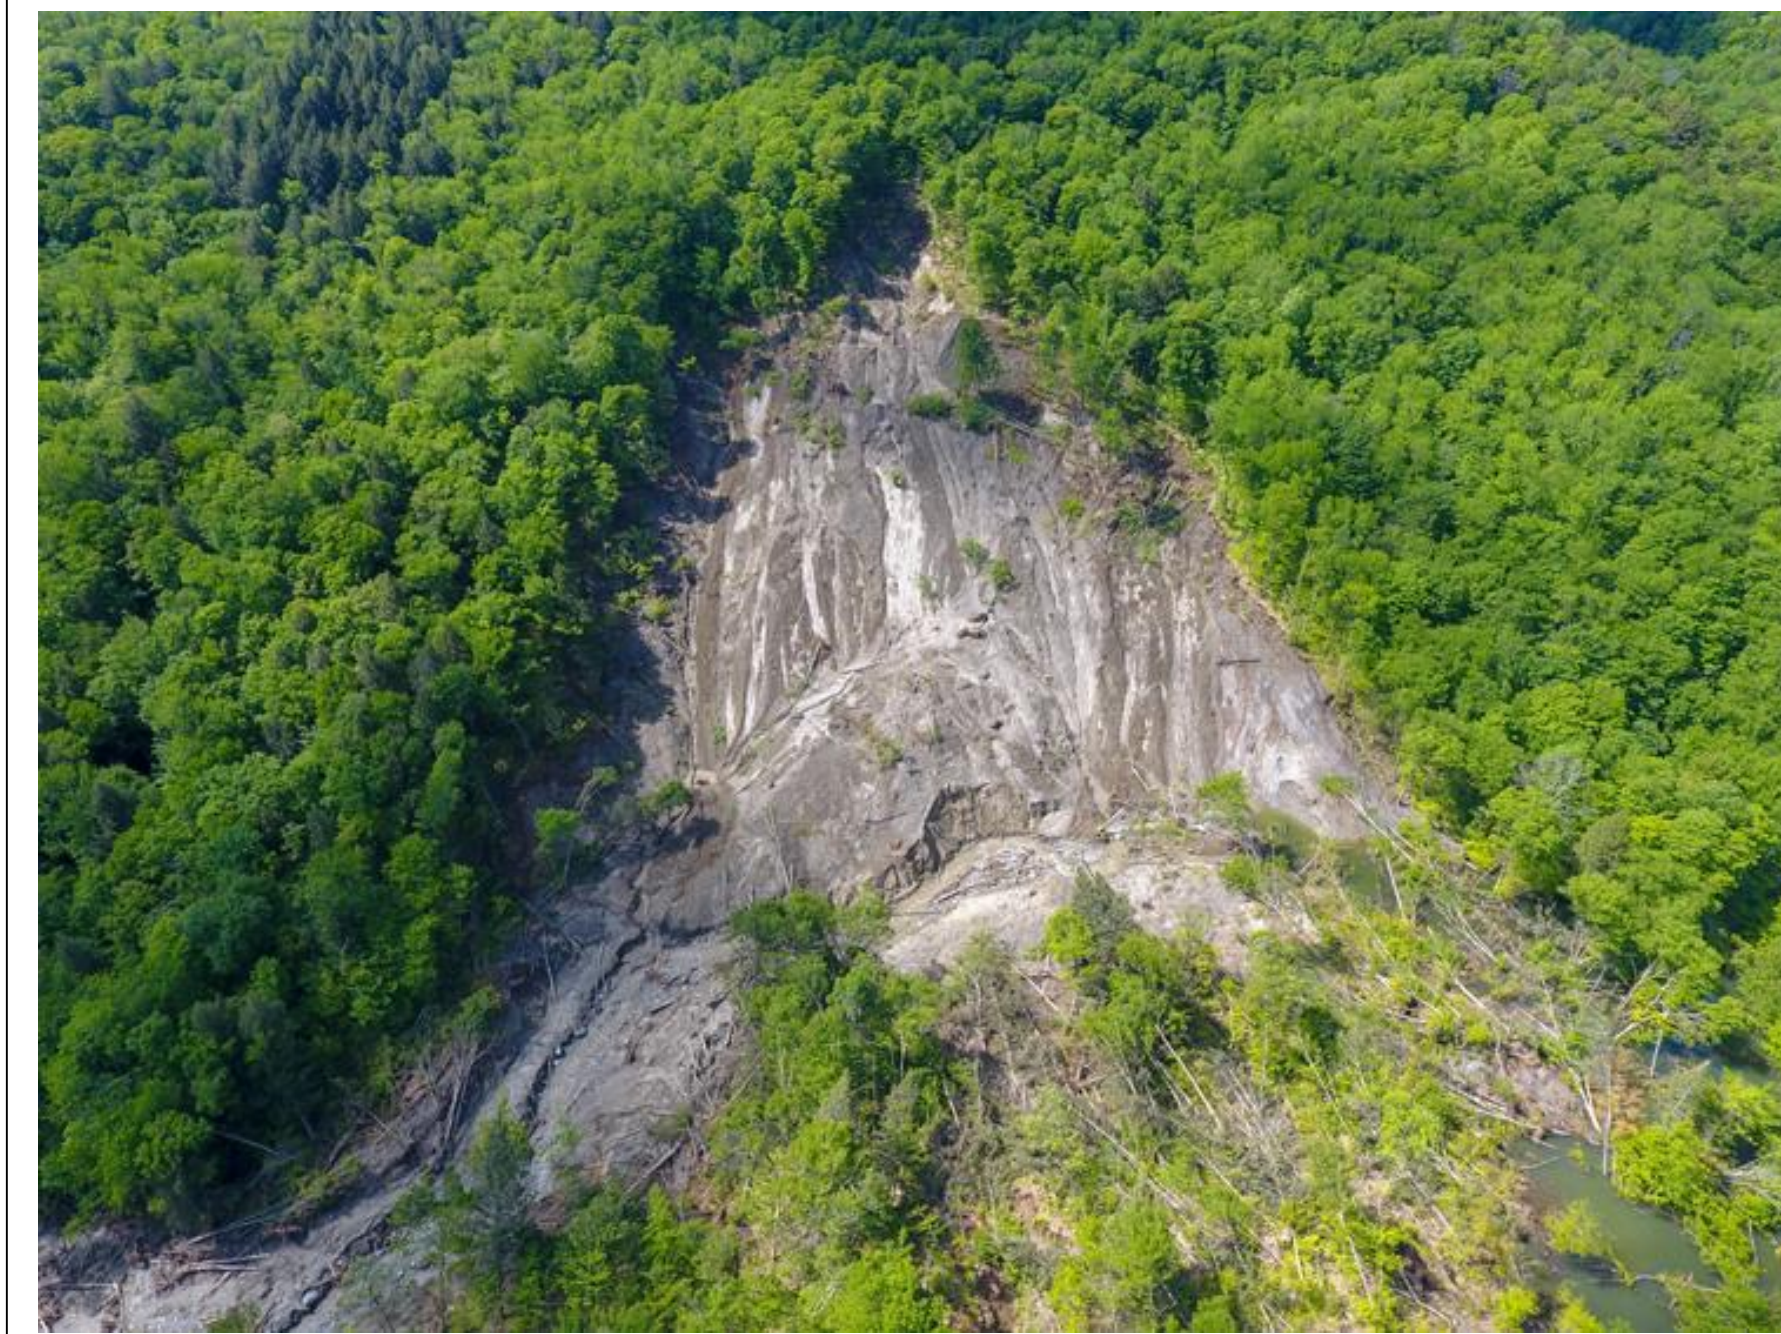
Fig 1. June 12, 2019: Drone flight by VTRANS showed 12 acres active plus 2.2 acres detached along the margins. ~100,000 cubic meters of material is in the toe deposit.

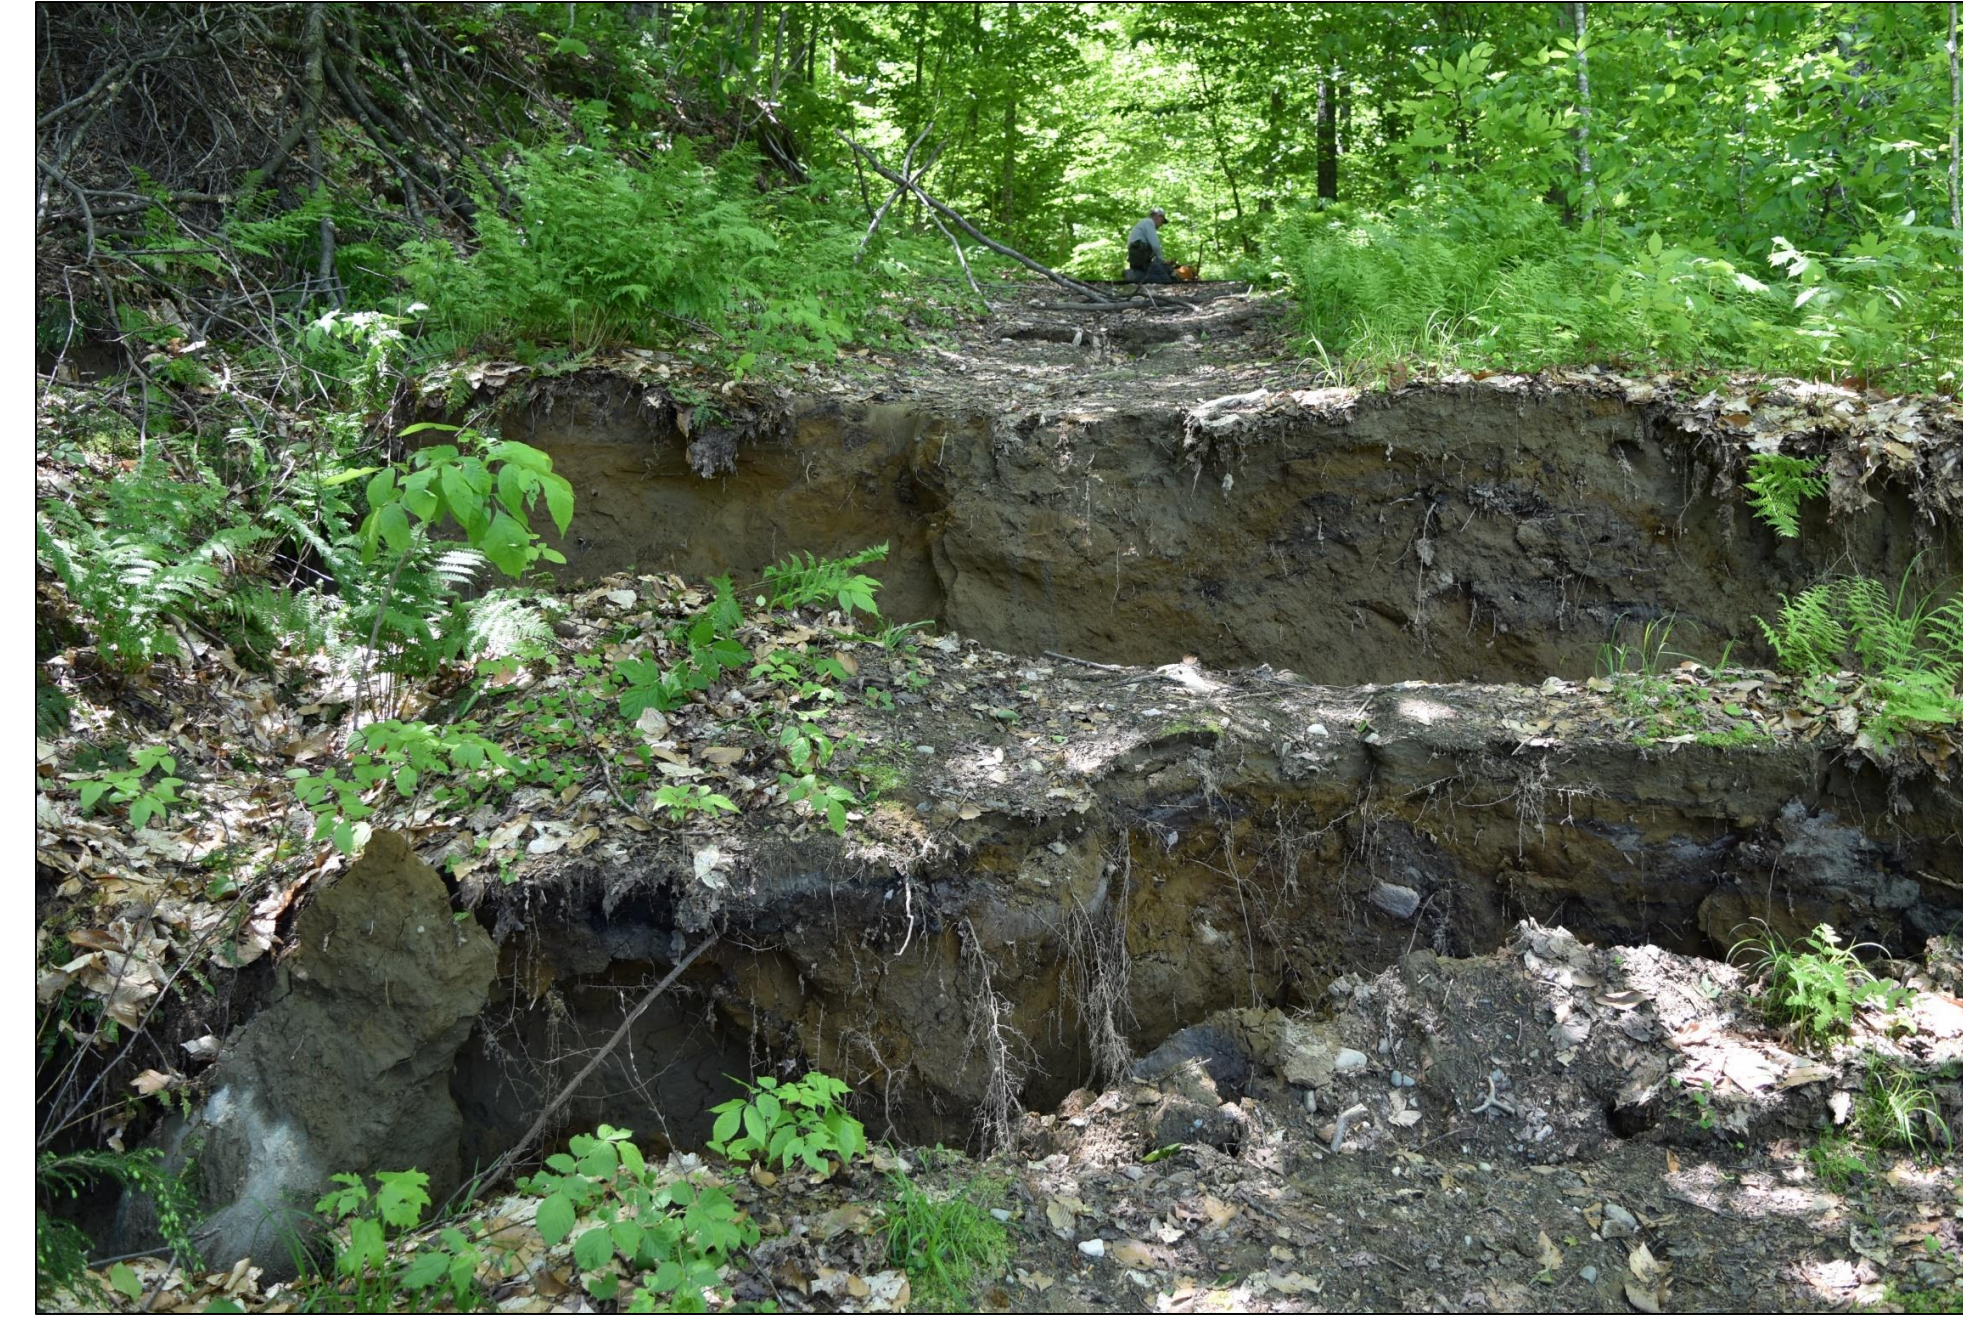
Fig. 2. June 12, 2019: Ground cracks and scarps due to rotational failure along landslide margins. Foster's Trail ended abruptly.

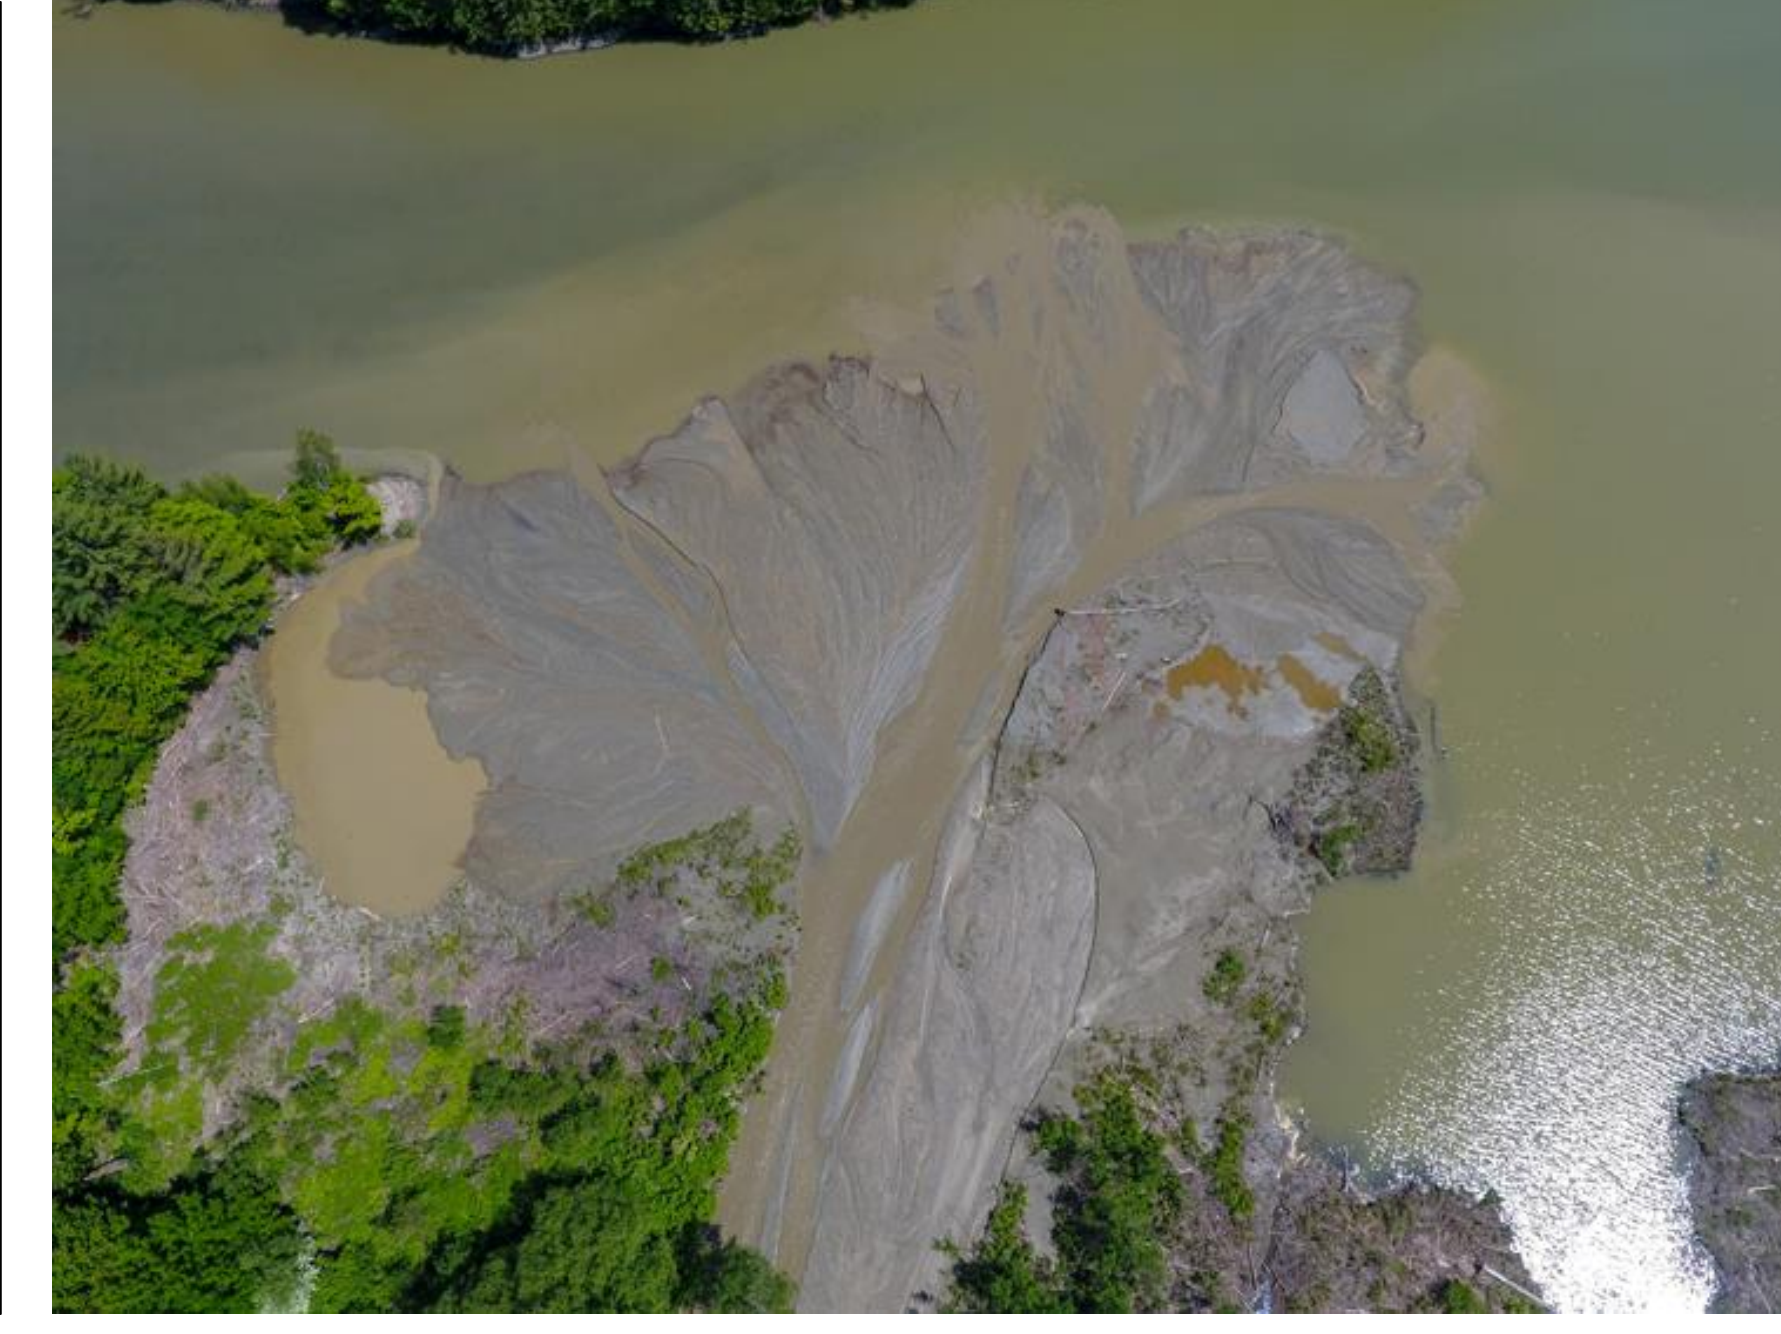
Fig 3. June 12, 2019: Downstream, a new delta formed in the Waterbury reservoir. The delta was ~2.8 acres.

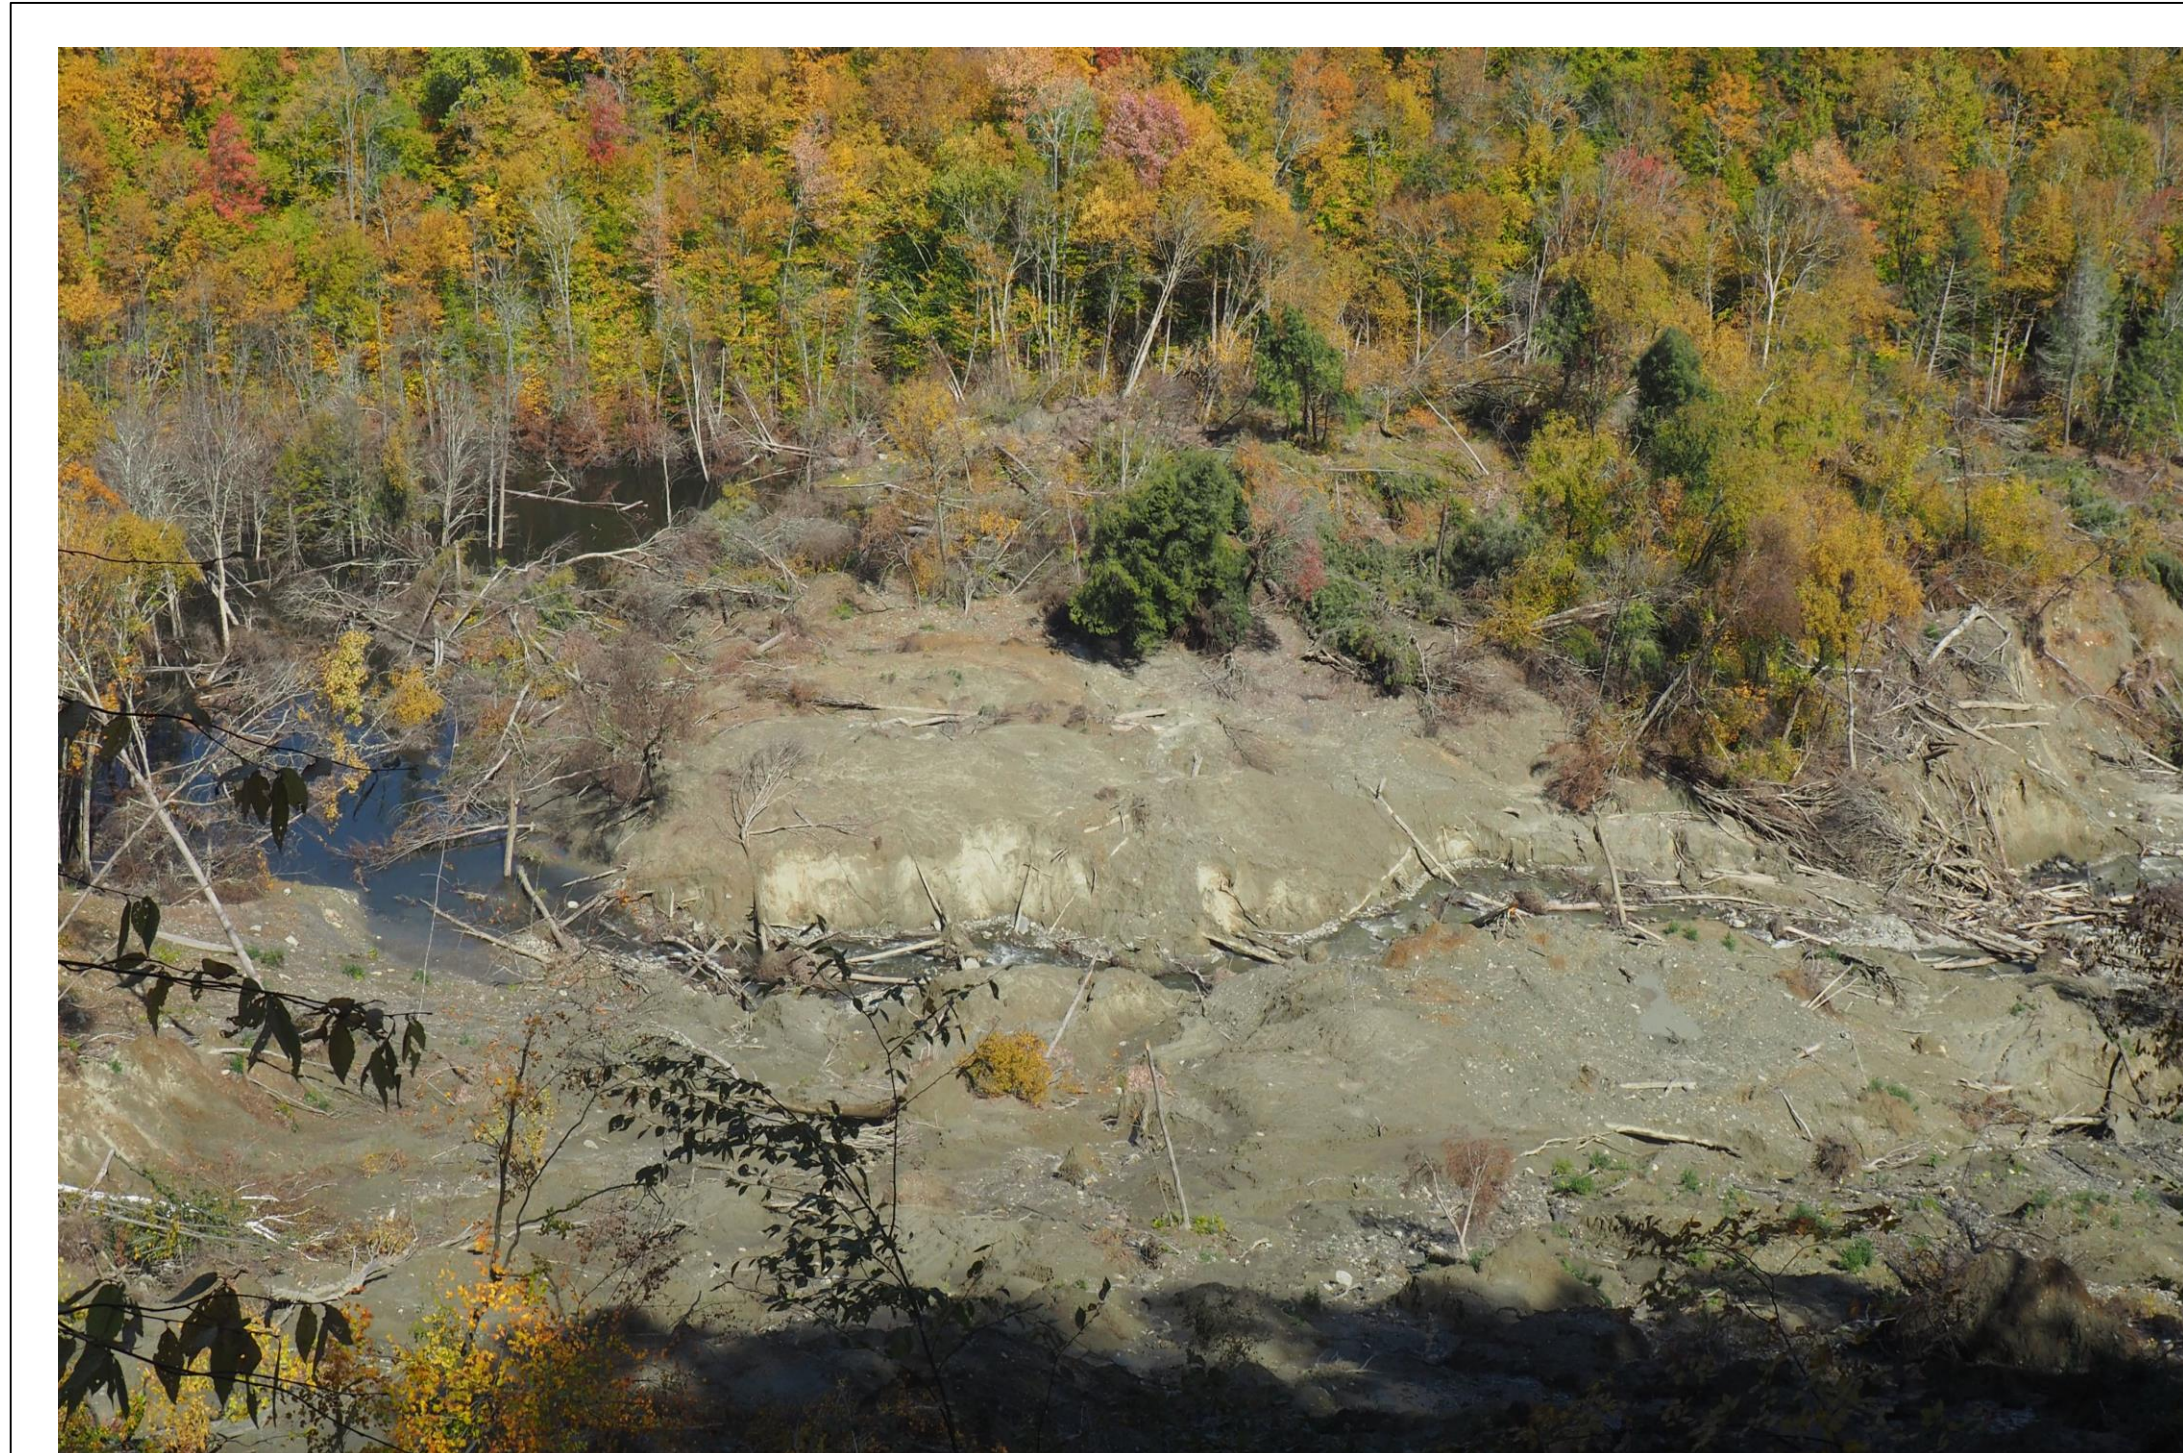
Fig. 4. October 8, 2019: View of the impoundment and the toe deposit. The pond extended upstream and encompassed approximately 1.8 acres.

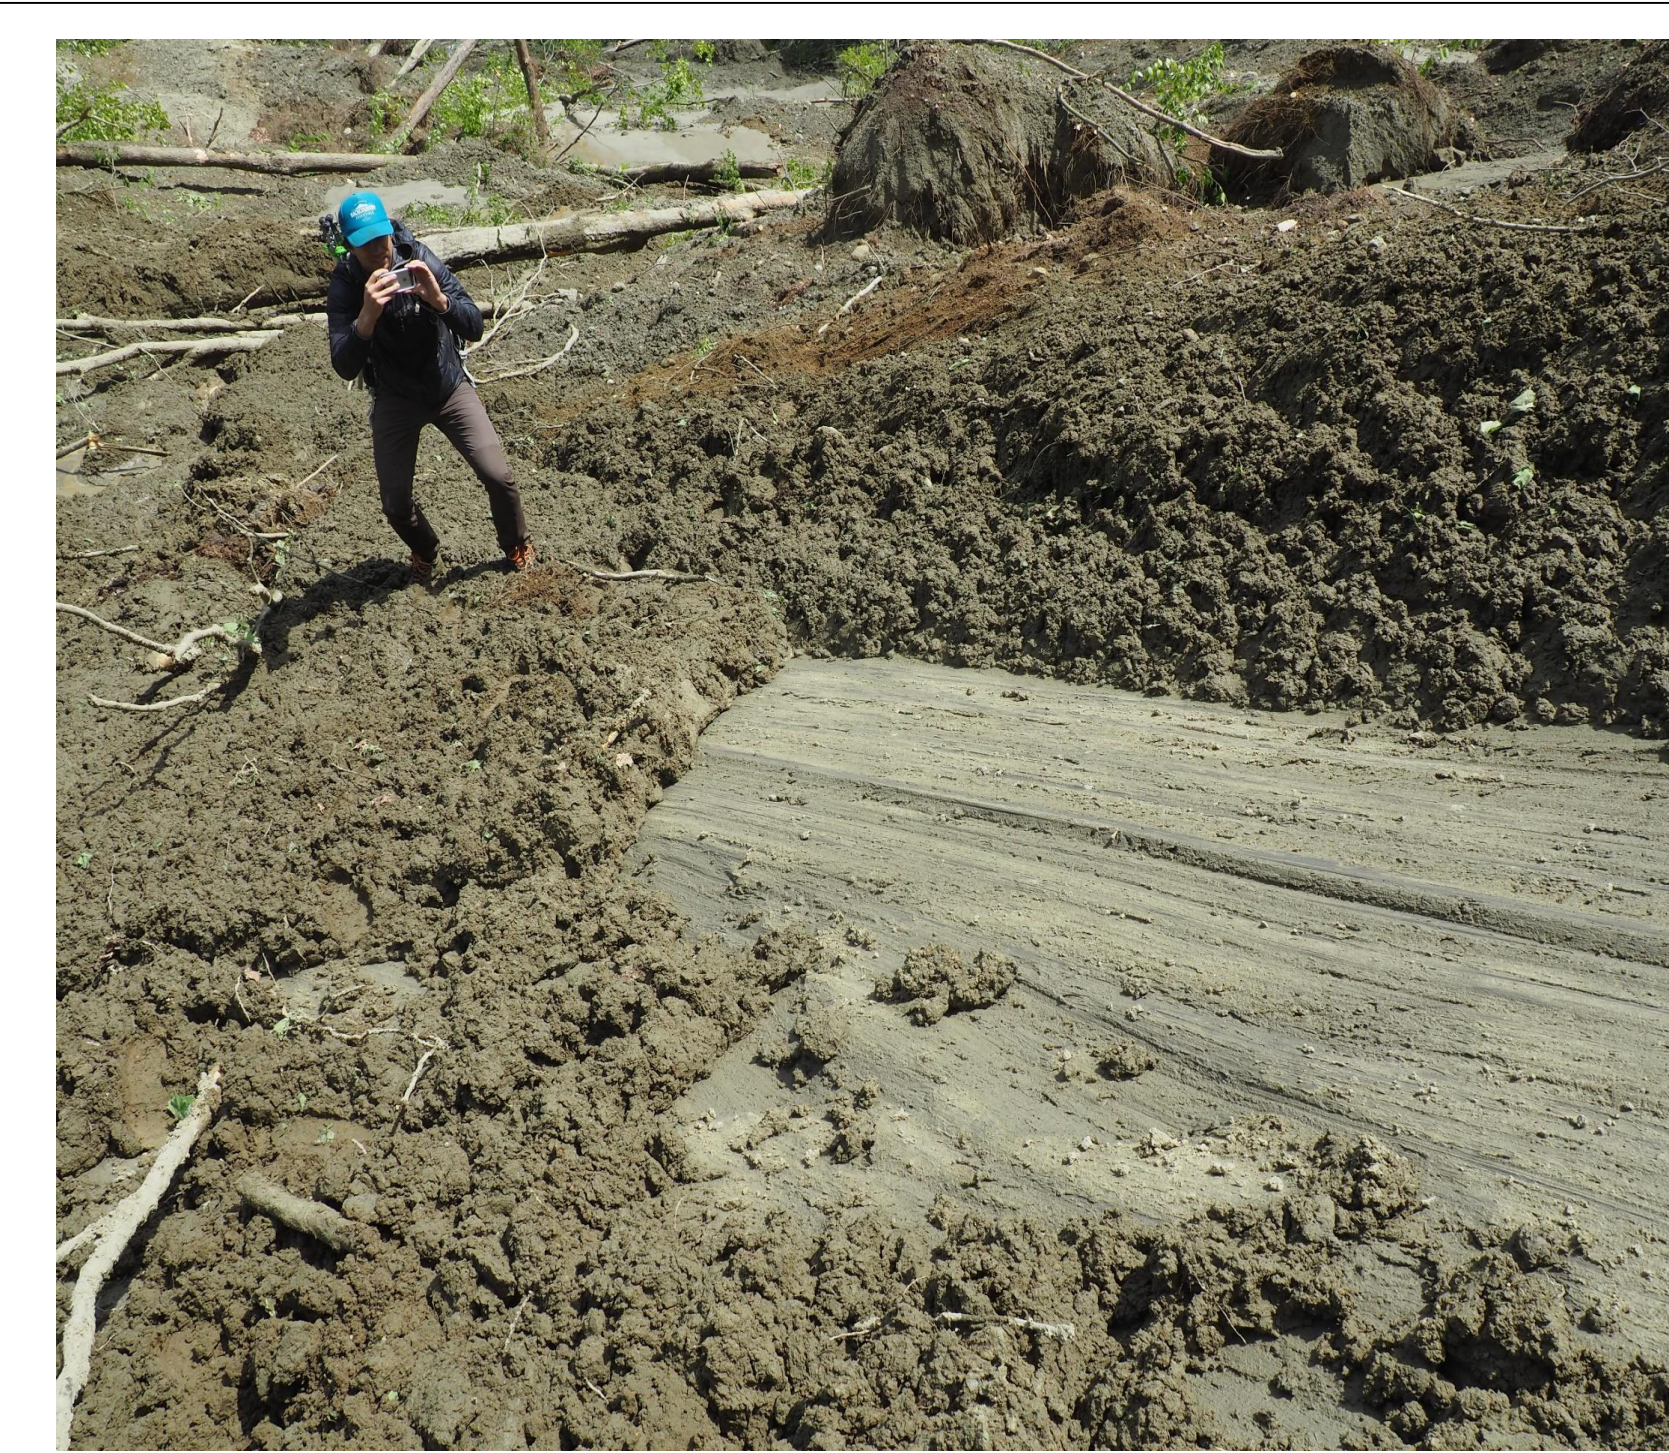
Saturation of unconsolidated material above the impermeable clay-silt layer (s), dipping slide surface, type of material (sand over clay), height (109 m), load balance, gravity, and steepness of slope are all likely factors influencing the mass failure; the causes are under investigation.

Fig. 5. June 4, 2019: Grooved, striated slip surface beneath sands, silt and debris near the base of the slope. No bedrock was exposed.

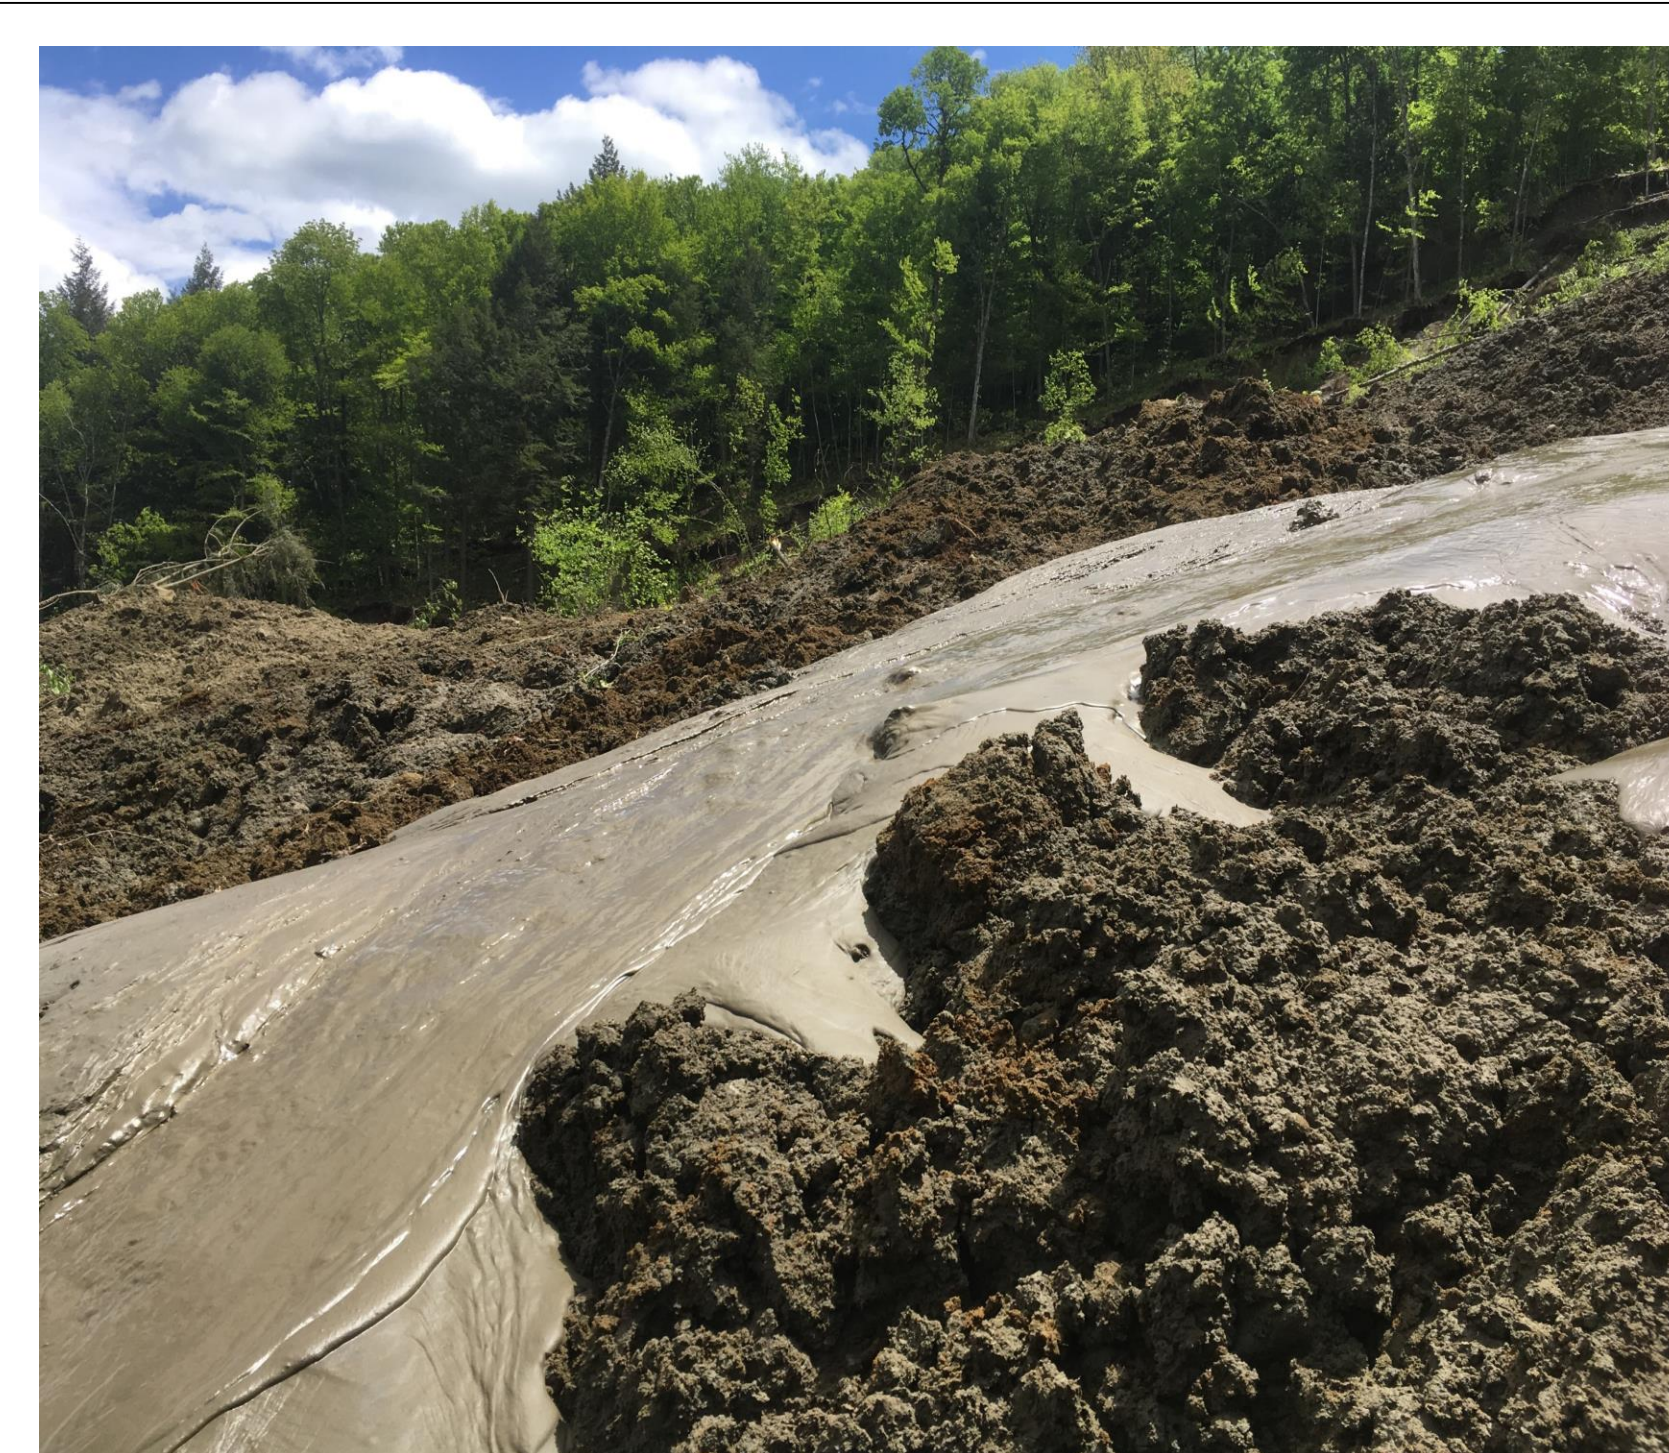
Fig. 6. June 4, 2019: Mudflows, saturated sand, boulders and trees indicated the site was still active. Water feeding the mudflows was from seeps partway down the slope, likely at a sand-silt interface or due to elevated water table.
