ABSTRACT
A major landslide occurred on the south side of Cotton Brook in the Mt. Mansfield State Forest in May 2019. The immediate goals of the Vermont Geological Survey were to 1) document threats in the area, 2) characterize the site, 3) propose approximate "exclusion areas" for trails, and 4) collect baseline data so we can evaluate impacts and change.

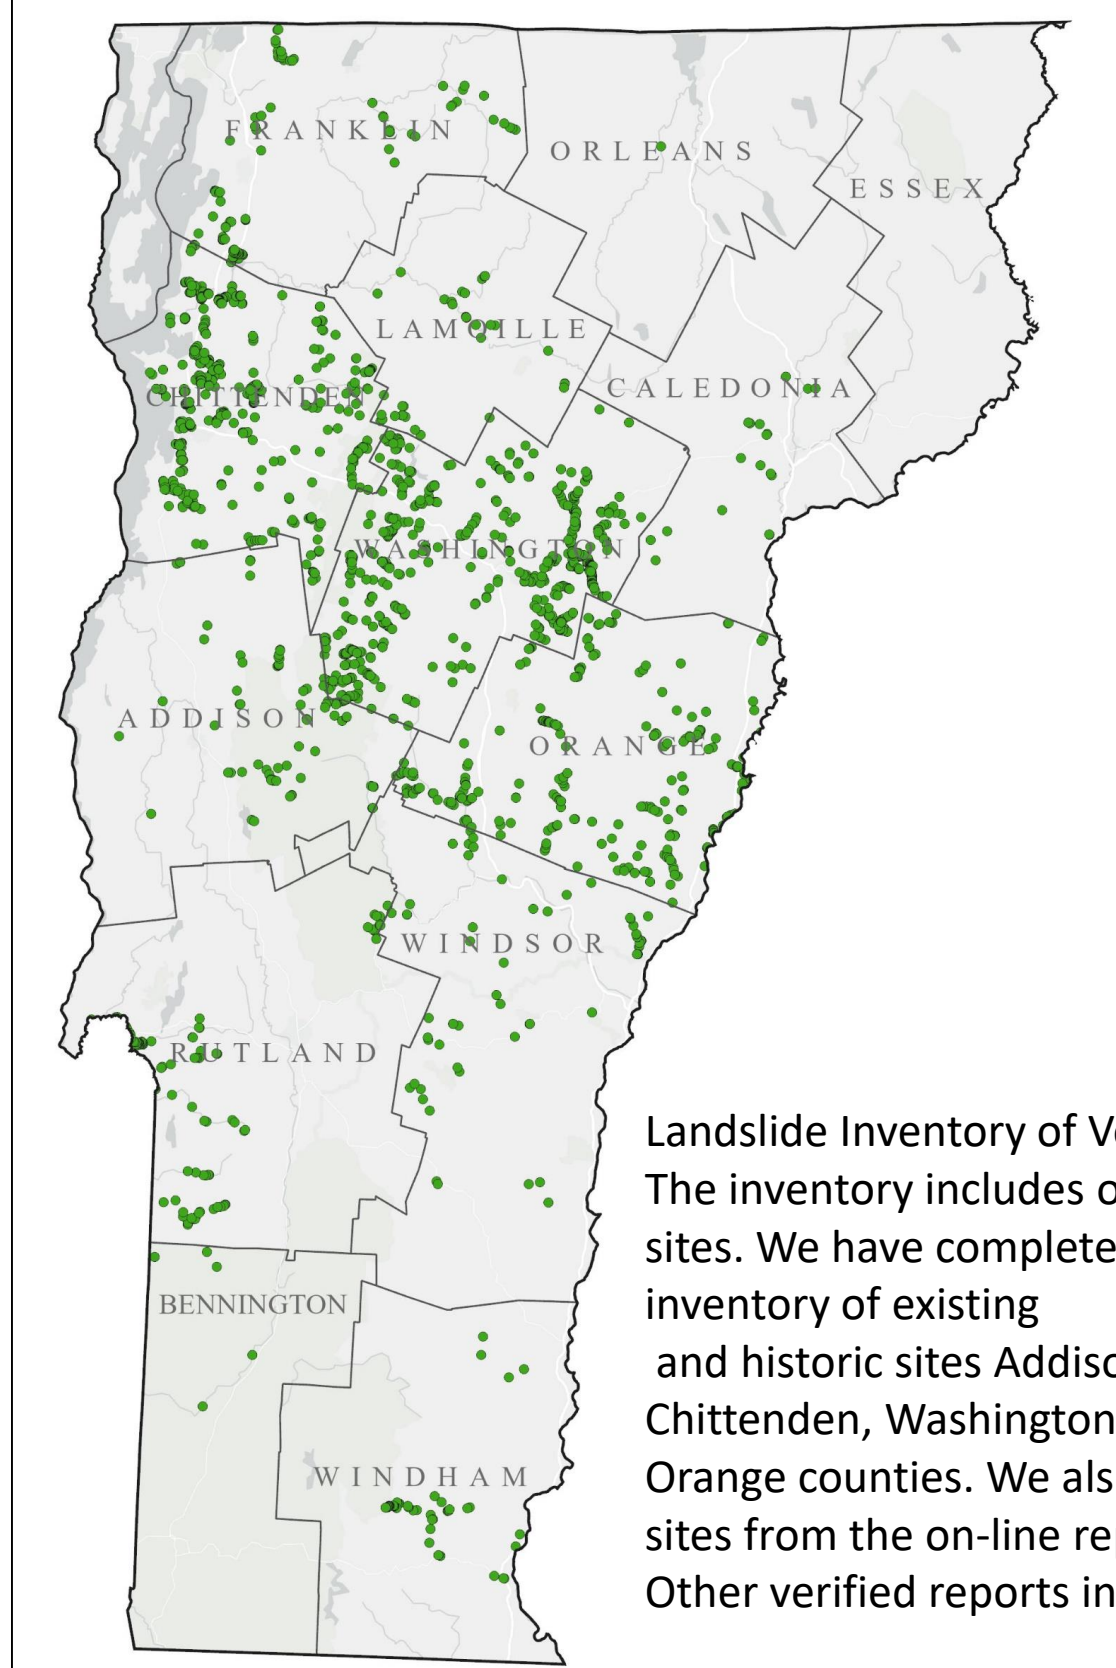
Landslide Inventory of Vermont, 2019
The inventory includes over 2100 sites. We have completed the inventory of existing and historic sites Addison, Chittenden, Washington and Orange counties. We also capture sites from the on-line reporter and other verified reports in Vermont.
