Mount Mansfield Stream Gages

Water Year 2016 report

U.S. Geological Survey in cooperation with Forest Ecosystem Monitoring Cooperative

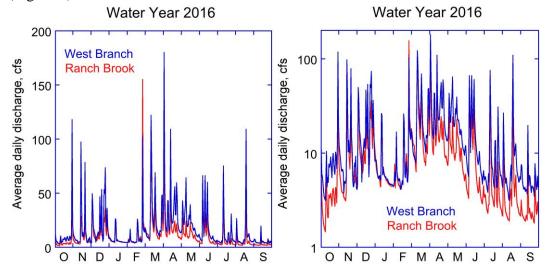
Figure 1. Streamflow at West Branch and Ranch Brook gages for Water Year 2016 (October 2015 through September 2016) in linear (left) and log (right) scales. The log scale plot highlights the higher sustained base flow levels at West Branch.

WY16 streamflow started off low following the very dry summer of 2015. After continued dry weather in October, the drought ended and November and December were rainy, as most late fall precipitation fell as rain (Figure 1). After a quiet start to the winter, with well below average snowfall (Figure 2), flows became very active in March and April, with earlier than usual snowmelt accompanied by rain-on-snow. The low

Streamflow, or discharge, is commonly reported as a volume per unit time – in the U.S., typically as cubic feet per second, or cfs (Figure 1). Throughout this report we typically refer to runoff rather than flow. Runoff is discharge divided by watershed area, and allows for direct comparison of flow in basins of different size. For example, if one basin is twice the size of another and has twice the flow, runoff would be the same. The dimensions of runoff are depth per unit time, i.e. the same as precipitation, thus runoff can be directly compared to precipitation. For example, if a watershed receives 1500 mm/yr of precipitation and has 1000 mm/yr of runoff, that means 500 mm/yr was lost to evapotranspiration plus or minus a change in the amount of water stored in the watershed, e.g. in soils.

The unusually early snowmelt and winter rain events led to high flows in March and April (Figure 1), and these months marked the only time that the WY16 cumulative runoff curve rose above the long-term average (Figure 3). With the snowpack largely gone in April and the ensuing average spring and dry summer, the WY16 curve quickly fell below the average. Although one year should not be viewed in isolation because of the high natural interannual variability in weather and climate patterns, WY16 conforms to future climate scenarios, with a higher percentage of winter precipitation as rain, less

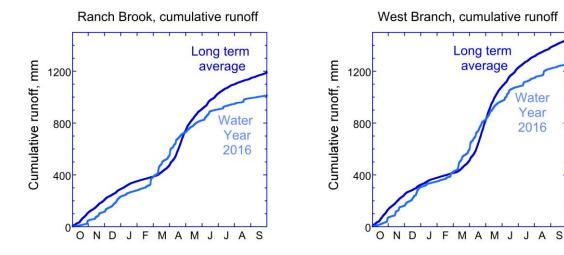
Figure 3. Cumulative runoff for Water Year 2016 (light blue lines) at Ranch Brook (left) and West Branch (right) plotted on the long-term (2001-2016) average at each site (dark blue lines).

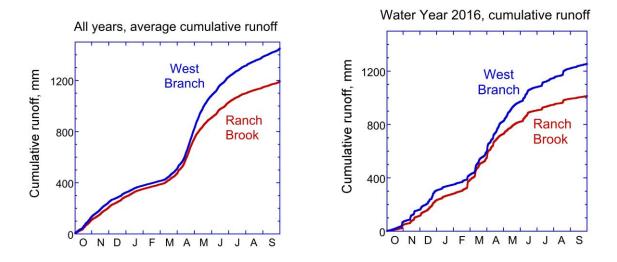
Figure 4. Average annual cumulative runoff at West Branch and Ranch Brook based on the daily averages across the 16-year record (left) and for Water Year 2016 only (right).

As noted in previous reports, West Branch has consistently yielded higher runoff (flow normalized to watershed area) than Ranch Brook (Wemple et al., 2007) (Figures 4 and 5). Over the long-term, the average difference has been 21% greater runoff at West Branch. The Water Year 2016 differential was slightly above average at 24% (Figure 5). We have repeatedly noted that greater runoff at West Branch is what we would expect from the creation of open land and development, but that the high magnitude of the differential suggests that some part of the difference may be natural. Historically, runoff from the two basins agreed quite closely until they diverged late in the snowmelt season and continued to diverge through the summer. Water withdrawals for snowmaking from West Branch (see gray box on snowmaking below) may have limited the natural difference between the two basins in fall and early winter, while that water returns to West Branch in spring as late snowmelt, accentuating the natural difference. Greater summer flow at West Branch is caused mainly by higher sustained baseflow (Figure 1). Cumulative runoff across the two basins in WY16 had a similar pattern to the long-term average, but the late-snowmelt divergence occurred about two weeks earlier.

Snowmaking alters the annual streamflow pattern by removing water that was headed downstream and storing it back up on the mountain as snow. This water has a "second chance" to make it out of the basin when the snow melts, usually several months later. Stowe Mountain Resort withdraws water for snowmaking from West Branch, at a point just upstream of the USGS gage. The position of the intake upstream of our gage assures that we are not double counting the water, and no water is imported from outside the basin (as at some ski resorts); therefore we can analyze the hydrology at West Branch as a "closed system". The effect of snowmaking is to redistribute water across the annual cycle. We measure less flow during withdrawal, and more flow during snowmelt. While the withdrawal immediately decreases the flow measured at the stream gage, the return of that water during snowmelt is a very gradual process, controlled by variable melt rates, and infiltration and slow movement through underlying soils. Also, some fraction of the water may be lost to evaporation and uptake by plants (transpiration). The longer melt period caused by the added snow from snowmaking is one cause of the differentially higher cumulative runoff at West Branch starting in May (Figure 4).

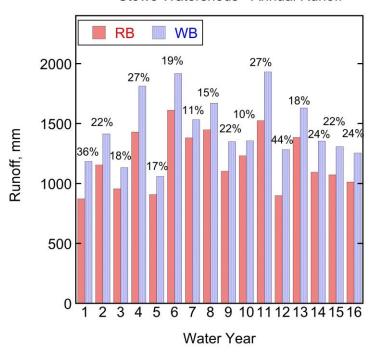
Stowe Watersheds - Annual Runoff

Figure 5. Annual runoff in mm at Ranch Brook (RB) and West Branch (WB) for the duration of the study though the present report year. The percentage of greater runoff at WB relative to RB is given for each year.
